S M -125A
Blair's Purchase Log House
Bushwood
Private

INVENTORY FORM FOR STATE HISTORIC SITES SURVEY

HISTORIC BLAIR'S PURCHASE SLAVE CABIN (SM - 125)

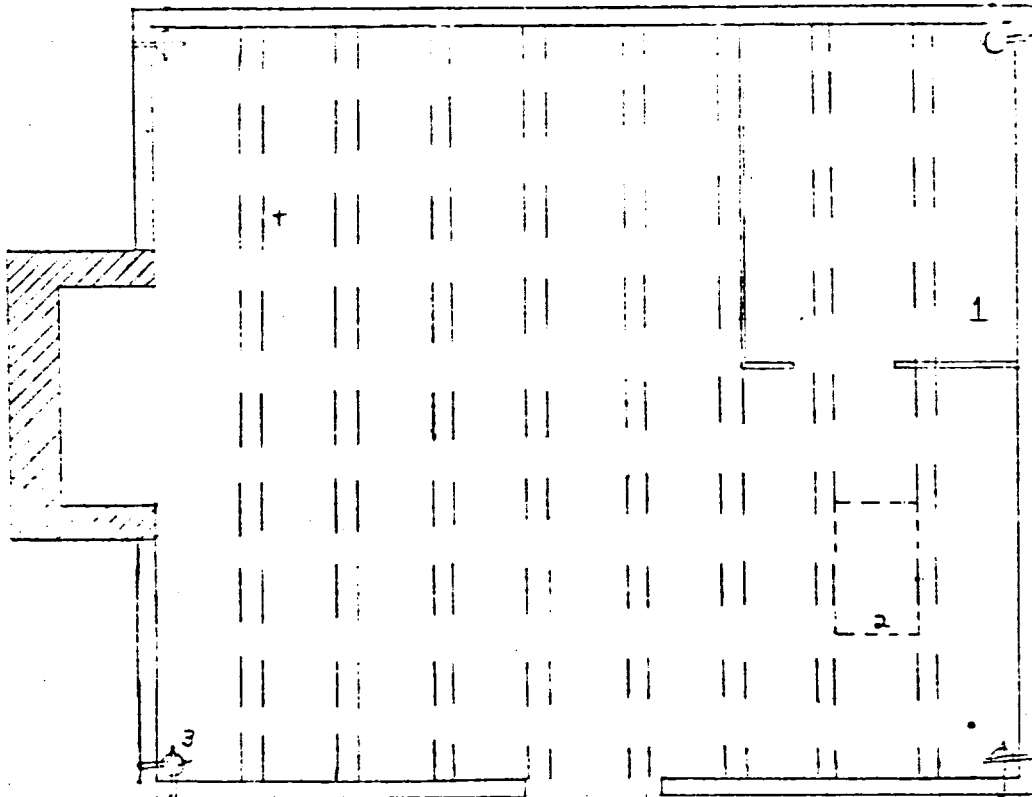
QUARTERS BY BLANK, PA
 ST. MARYS COUNTY, MD
 2-1-1915

NOTES:
 1: PARTITIONED SPACE
 2: OPENING INTO LOFT
 3: PEGGED CORNER POSTS
 4: OVERHEAD JOISTS
